Research Report TM/80/08
1981

Visual requirements and lighting standards in mining operations. Final report on CEC Contract 6245-11/8/048

Visual Requirements and
Lighting Standards in
Mining Operations

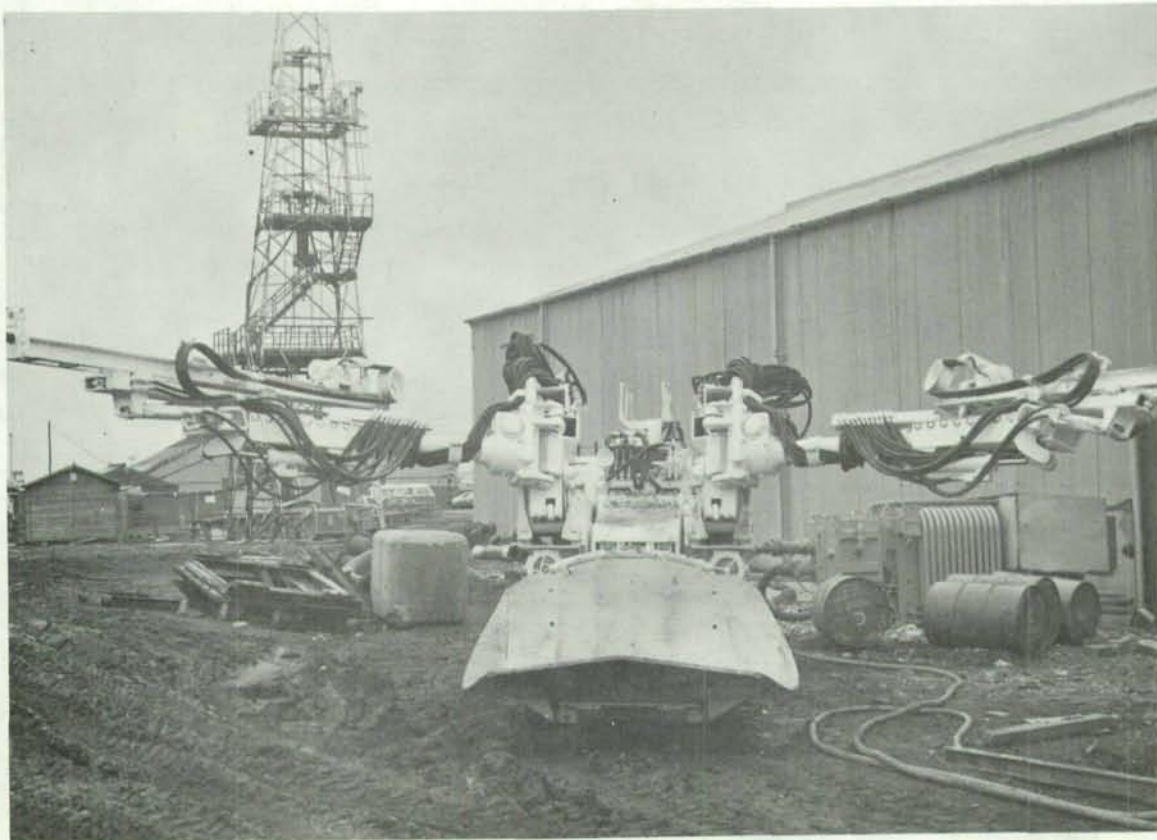
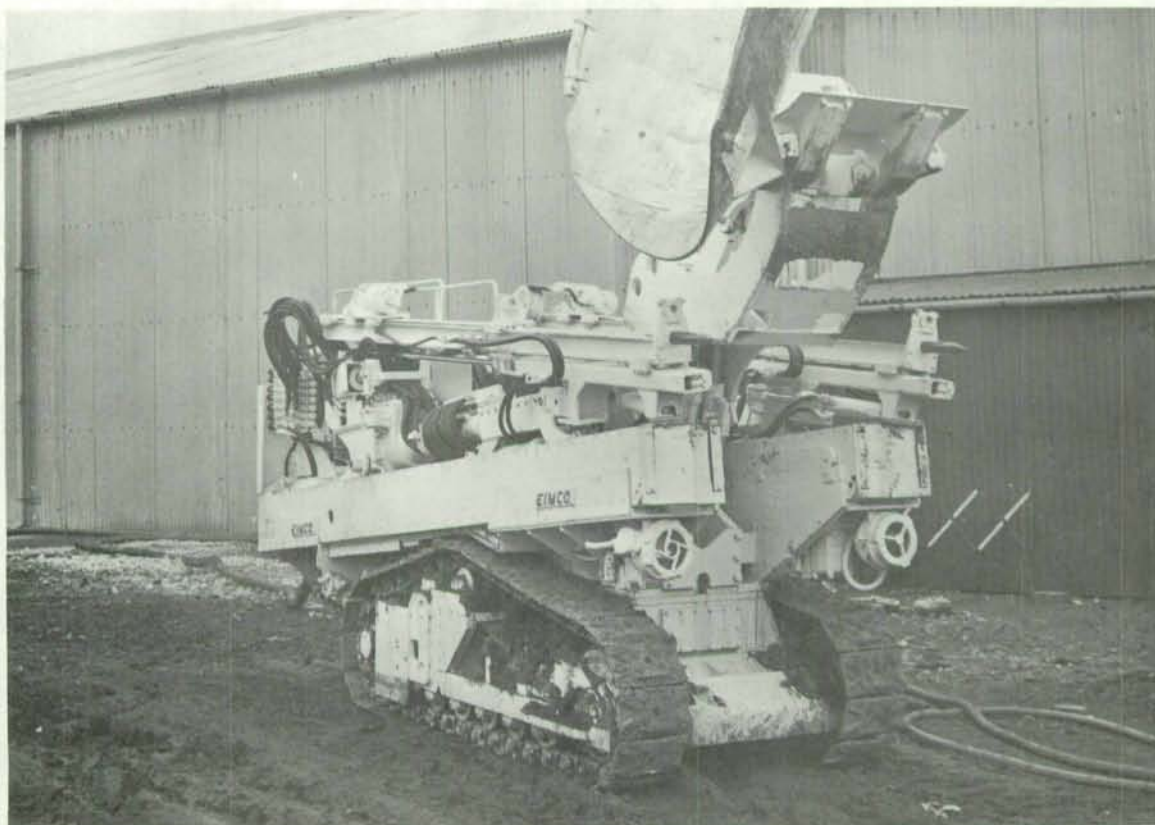
FIGURE 9.

FIGURE 9 - A General Illustration of the Misplacing of Lamps on Heading Machines

Headlamp location also contributed to the inadequacy of the lighting. They were frequently mounted on the main body of the machine and obscured by moving parts. A general illustration of this is shown in Figure 9. The lamps are fitted to the machine chassis, and their light may be obscured by the bucket whenever it is raised or lowered. Some lights were observed attached to the base of a drilling arm but, as the drill carriage could be moved independently of the arm, the light beam was only directed towards the drill bit when the drill and arm were in line, at which point the arm cast a shadow obscuring the bit. The headlamps seen were too large to be easily mounted on the drill carriage.
